VIGILANTE FORENSIC

Report of: William J. Vigilante, Jr., PhD, CPE

Date: July 31, 2018

Case Caption: Pamela Brackin
Vs.
Medtronic, Inc., et al.

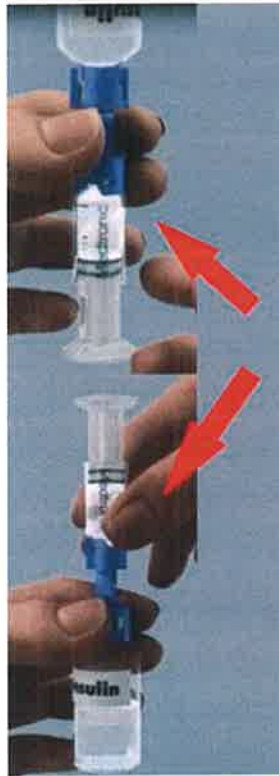
Figure 1. Pictograph for step 6a.

The instructions should have conspicuously and explicitly instructed the user on the proper orientation and position of the reservoir when removing it from the transfer guard (1-3,5, 8-11). The warning should have alerted the user to the potential hazard associated with any liquid contaminating the P-cap connector, the need to ensure the top of the reservoir and P-cap connector were dry before connecting them, to dispose of the infusion set if liquid got on the P-cap connector, and the consequences of failing to properly complete the steps (i.e., over or under infusion of insulin). For example, Medtronic and Unomedical should have ensured the Getting Started guide highlighted the need to flip the unit over and ensure the reservoir was above the insulin vial before removing it from the transfer guide. An intervening pictograph (e.g., 8a) of the “To Fill the Reservoir” instructions should have been provided showing the reservoir-transfer guard-insulin vial being inverted as depicted in Figure 1. The pictograph should have included conspicuous arrows to indicate and emphasis that the reservoir was flipped over. For example, Amichai Vardi, Medtronic’s prior director of quality, testified that an arrow is used to emphasize the flipping of the unit (AmV, 45,46,268).

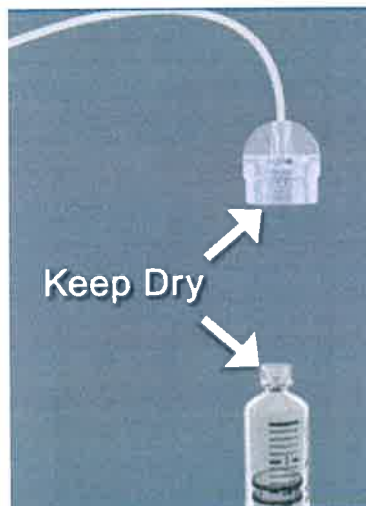
Figure 2. Pictograph for step 7a.

In addition, step 1 of the “To Connect the Tubing” instructions should have been expanded to include a 1a: check top of reservoir before connecting to P-cap. Step 1a should have included a pictograph such as depicted in Figure 2.

A warning should have accompanied step 1a of the “To Connect the Tubing” instructions which stated (11):
